AIRSWEEP
MATERIAL ACTIVATION SYSTEMS

AirSweep System Fixes Several Flow Issues Along Titanium Dioxide Processing Network

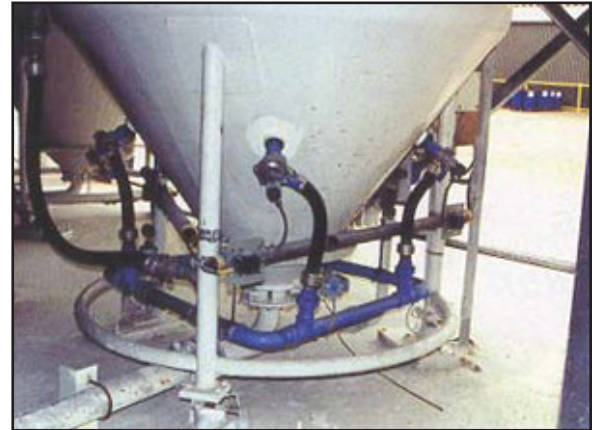
VA-12 AirSweep System mounted to the bottom of TiO₂ hopper.

To correct the problem, the company replaced the feeder with a live bin bottom (multiple screw feeder) and installed a ring of **four Model VA-12 (1-1/2") AirSweep units** about 2 feet above the live bottom. When a flow detector sensed bridging above the live bottom, the AirSweeps were automatically activated and a **steady material flow was achieved**.

The flow of TiO₂ from the live bottom system was now feeding beyond the capacity of the system's screw conveyor. A **collection hopper** was put into service as a buffer hopper to feed the screw but the material would immediately bridge above the 10" diameter outlet. By **installing an additional four VA-12 AirSweeps on the buffer hopper**, the **bridging was eliminated** and steady feed rates to the screw were ensured.
